HOME INSPECTION

08/28/18

5616 S Magnolia Ave St. Louis, MO 63139

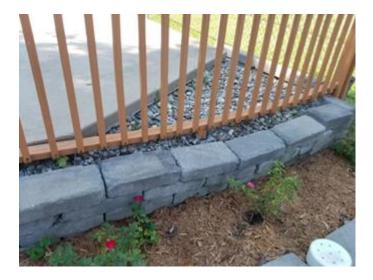
Exterior - Retaining Wall

M Issue There is minor movement in the retaining wall. The cause for this should be determined, and repairs

made to prevent further movement.

Location Rear

Action Hire a contractor to evaluate the movement and provide repairs as needed.

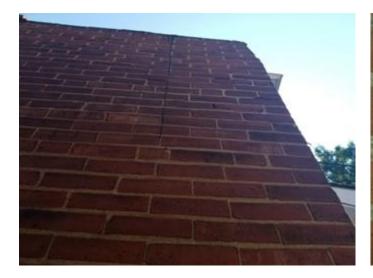
Exterior - Siding

Issue

There are deteriorated mortar joints in the siding. This permits moisture penetration and will cause further damage.

Location Right Side

Action Repair the mortar joints.

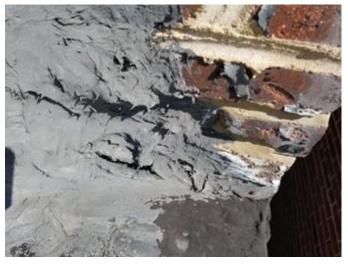
Issue The roofing is deteriorated. This permits water penetration.

Hire a roofing contractor to provide repairs or replacement as needed. Action

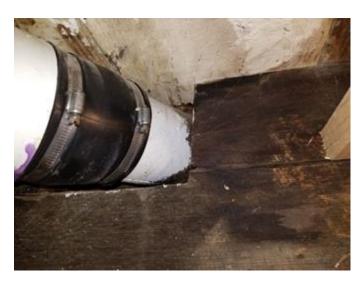
Location Basement near plumbing stack.

Hire a contractor to repair or replace the joist.

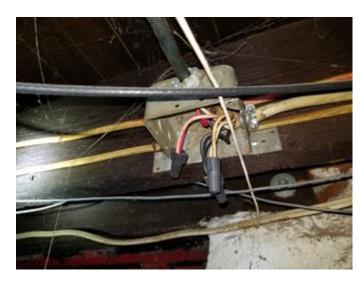
There are missing junction box covers. This is a safety concern that defeats the box's fire rating and permits contact with energized components.

Location Basement

Action Hire a contractor to make required repairs.

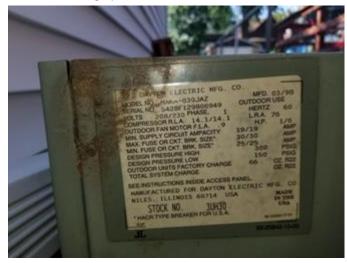
HVAC - Cooling System

The cooling system is past the end of its useful life. We recommend establishing a budget to replace the cooling system.

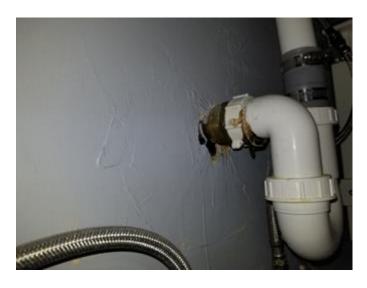
Issue The sink drain is leaking. This can allow water damage.

Location Bathroom

Action Repair or replace the drain.
