HOME INSPECTION

08/01/16

1234 Oak Street
Manassas, VA 20109

Prepared with care for
Joe Sample

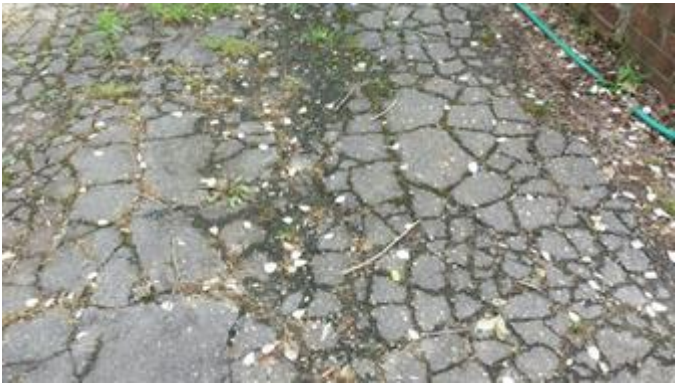
Issue	The driveway is deteriorated. Cracks permit moisture to enter, which can cause further damage. Uneven surfaces are trip hazards.
	Location	Right side of the house
	Action	Replace the driveway.

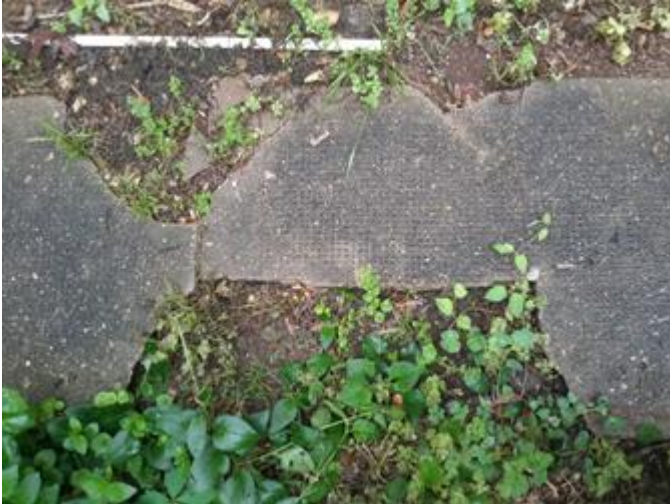
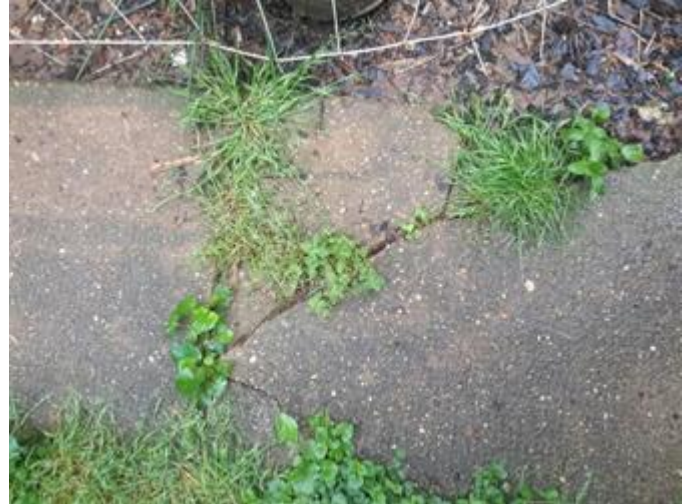
**Issue** The walk is deteriorated. This is a tripping hazard, and will allow water penetration to cause further damage.
- Location** Left side, Rear
- Action** Hire a contractor to make required repairs.

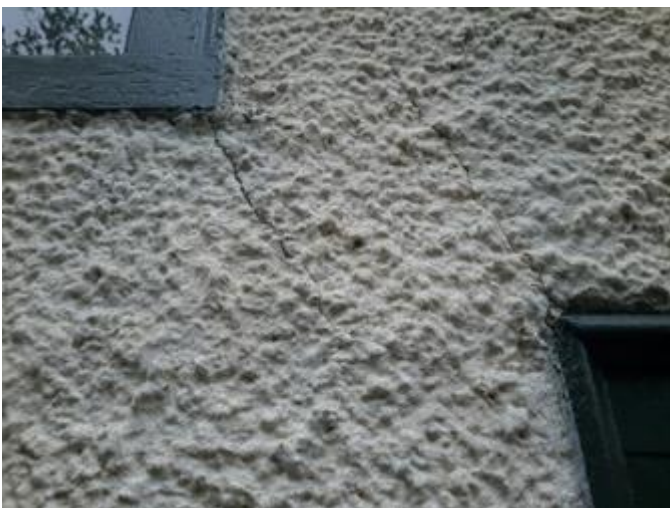
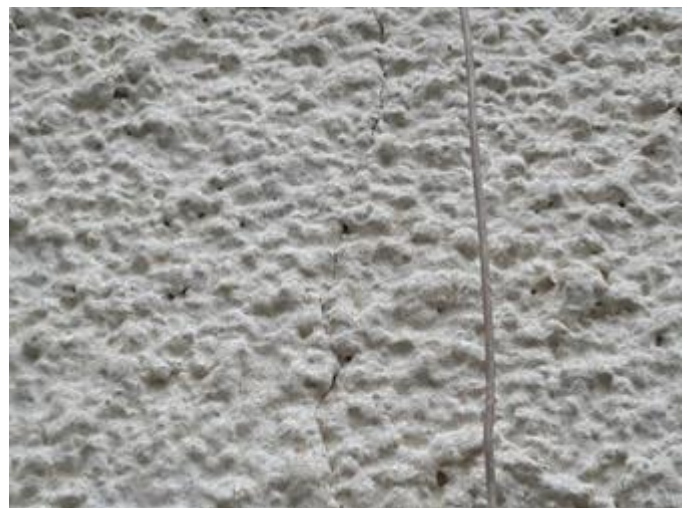
**Issue** There are cracks in the siding. This permits moisture penetration and will cause further damage.
- Location** Left side center window, Left side front, Rear downstairs window
- Action** Hire a contractor to make required repairs.

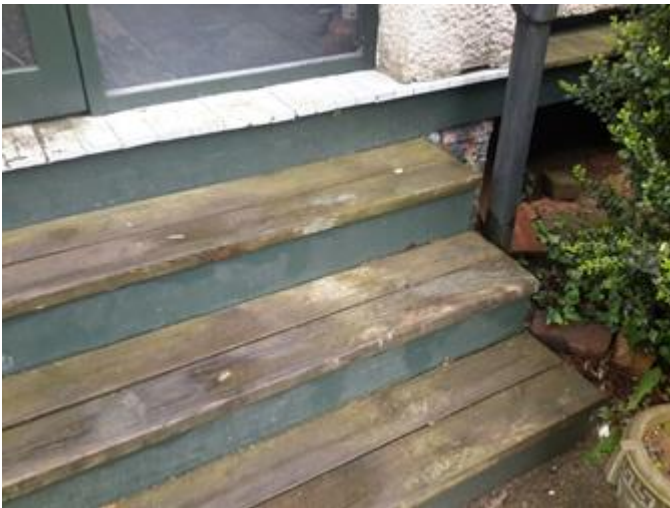
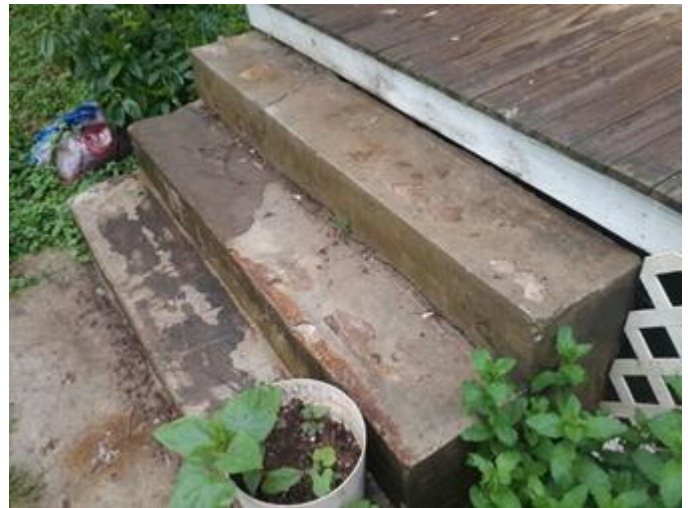
✗ Issue The handrail is missing. This is a safety hazard.
Location Front and rear porches
Action *Install a handrail.*

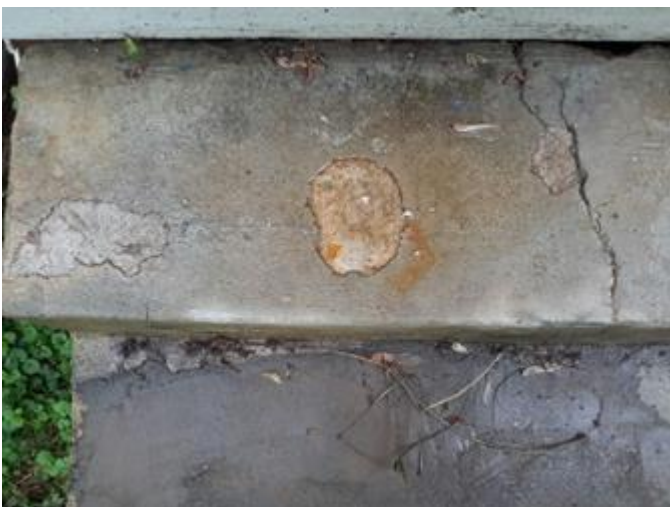
✗ Issue There are cracked steps. This permits water penetration, and will lead to further damage.
Location Rear porch
Action *Repair or replace the steps.*

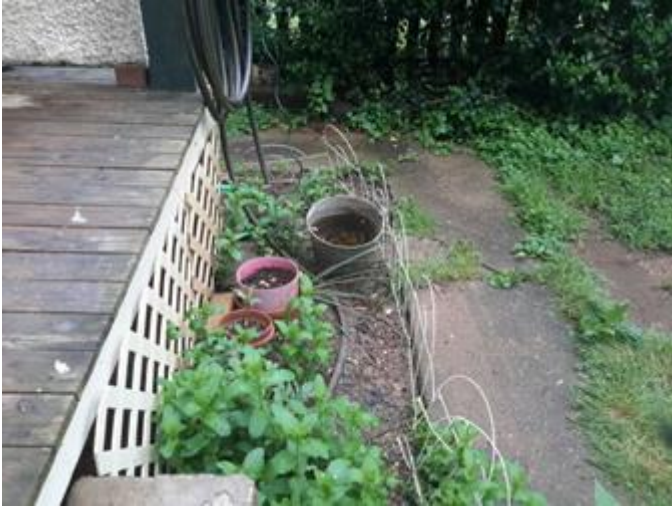
- X** Issue The guardrail is missing. This is a safety hazard.
Location Rear porch
Action Hire a contractor to make required repairs.

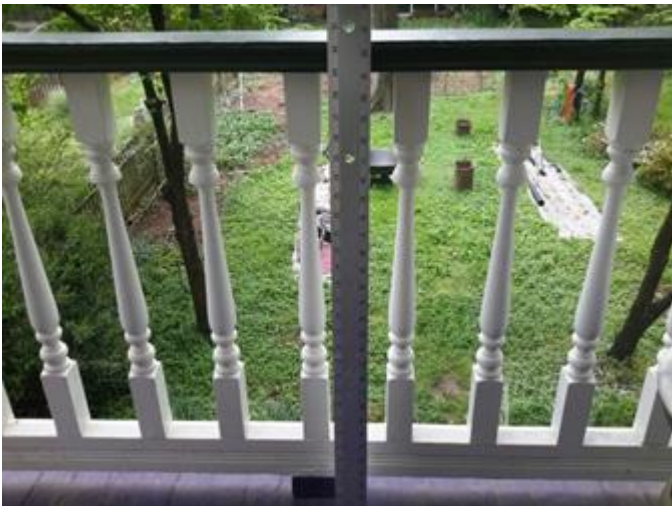
- X** Issue The guardrail is too low. This is a safety hazard. Guardrails should be at least 36" high.
Location Rear balcony
Action Hire a contractor to make required repairs.

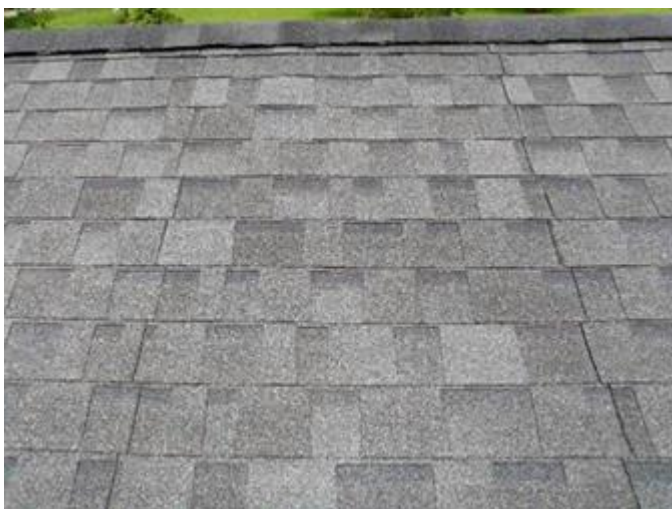
- X** Issue The shingles are improperly installed. The ends of the tabs line up and are not offset from one row to another. This can allow leaks.
Location Main roof
Action Hire a contractor to make required repairs.

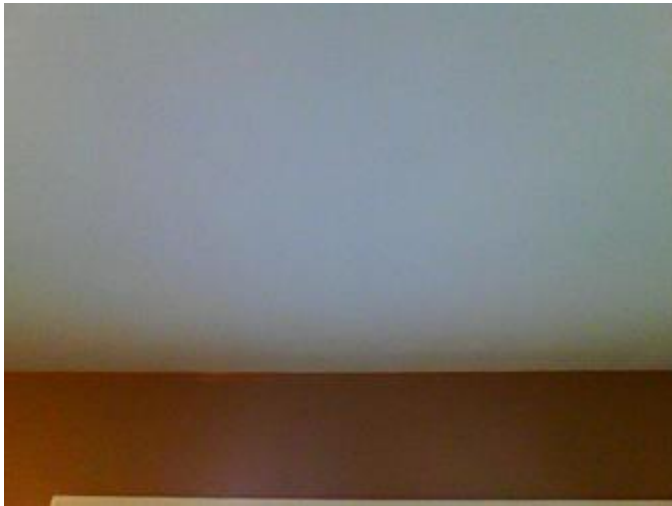
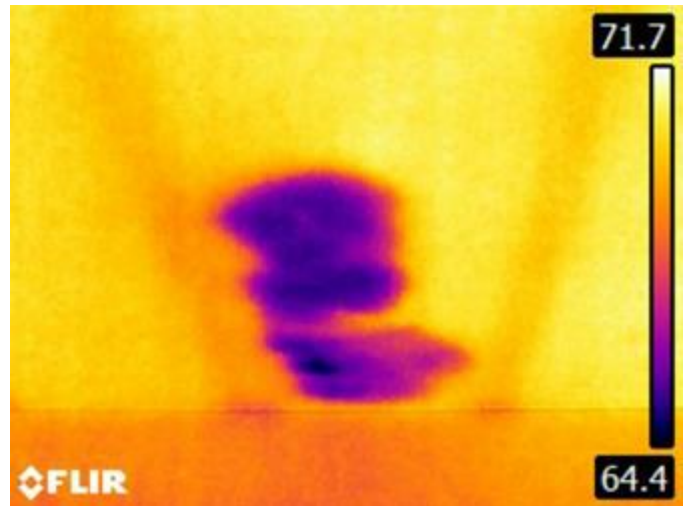
- X** Issue The roof is leaking. This will allow interior damage. The included infrared image clearly shows an area of temperature difference consistent with moisture pooling in the ceiling. Moisture is confirmed with a moisture meter.
- Location Front right bedroom, right wall
- Action Hire a contractor to make required repairs.

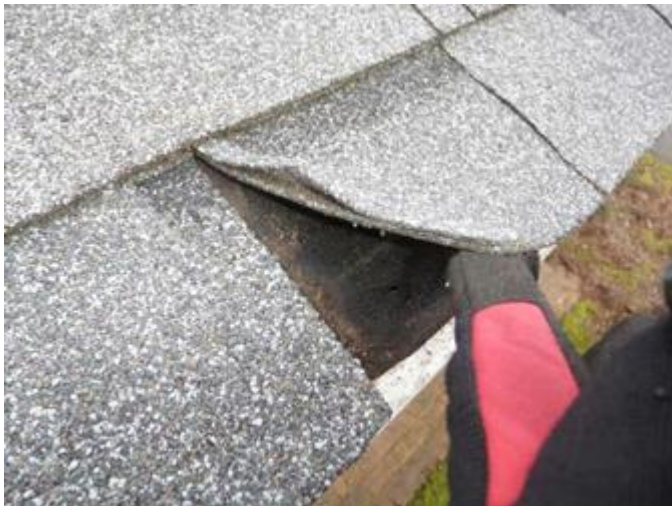
- X** Issue The starter course of shingles is missing at the eaves. This will allow leaks and cause deterioration.
- Location Front dormer
- Action Hire a contractor to make required repairs.

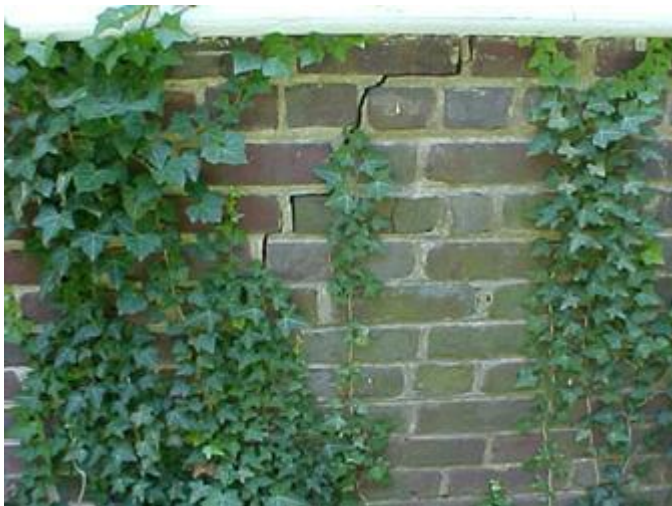
X Issue	There are step cracks in the foundation wall. Step cracks indicate that the foundation has settled or is settling.
Location	Right rear corner
Action	<i>Hire a contractor for an evaluation and to make required repairs.</i>

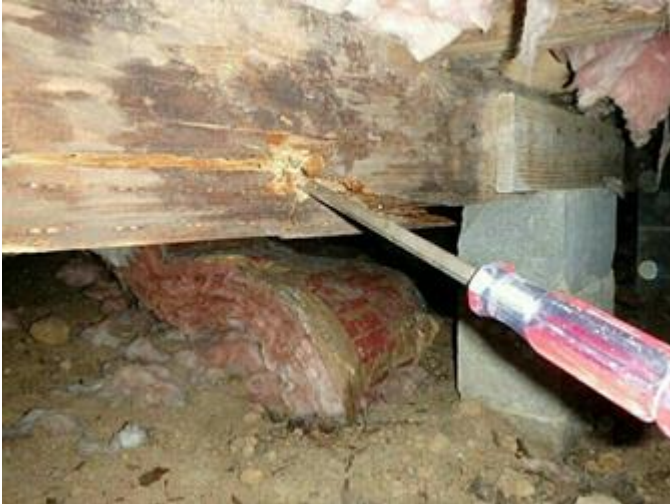
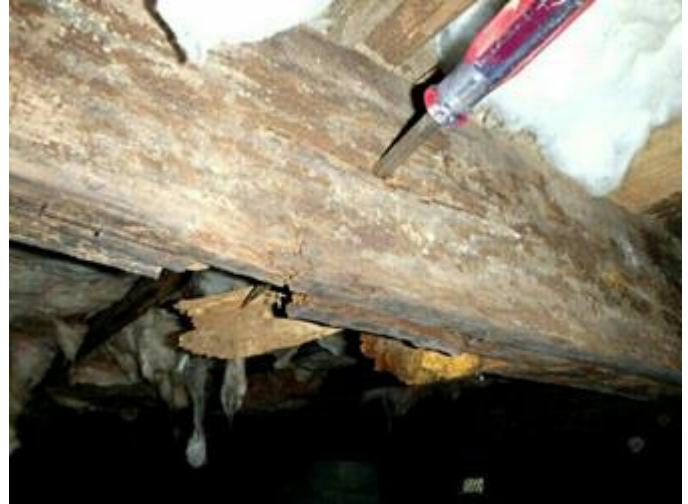
- ❌ Issue The beams are deteriorated. This can affect their load-bearing capacity. The cause of the deterioration should be identified.
- Location Left side of the crawlspace
- Action Hire a contractor for an evaluation and to make required repairs.

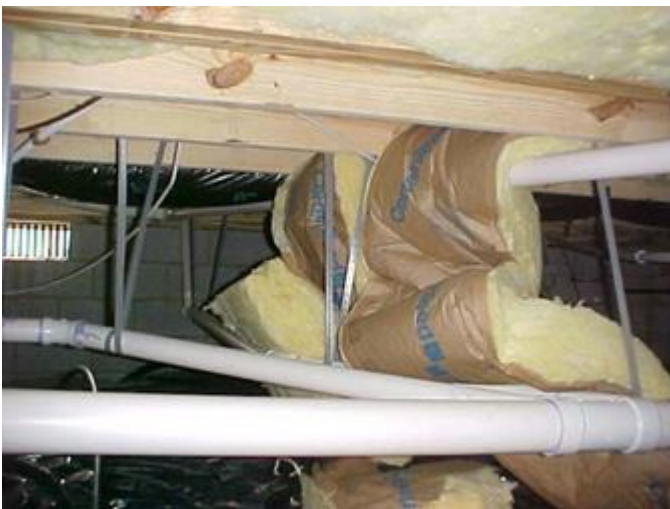
✗ Issue There is loose or falling insulation inside the crawl space. This affects energy efficiency.
Location Right side of the crawlspace
Action *Repair or replace the insulation.*

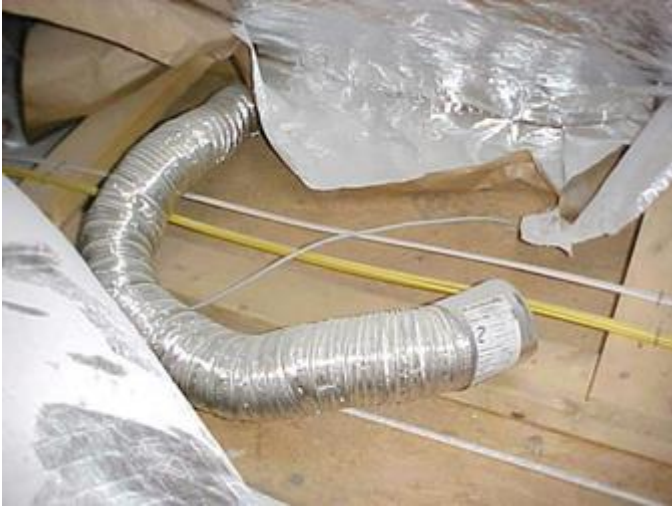
- ❌ Issue The bathroom fan is venting into the attic. This can lead to moisture and mold/mildew problems.
Location Above the master bathroom
Action Hire a contractor to make required repairs.

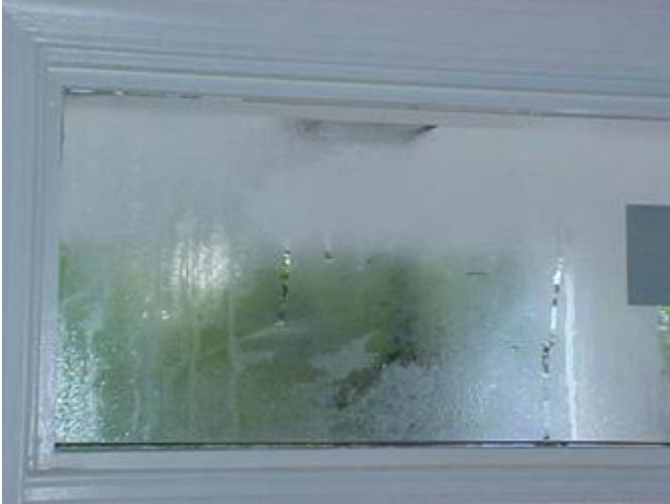
- ✕ **Issue** The window has a failed insulated glass seal. This permits condensation stains to develop on the inside of the glass and will increasingly compromise visibility and appearance.
- Location** Kitchen sink
- Action** *Repair or replace the window.*

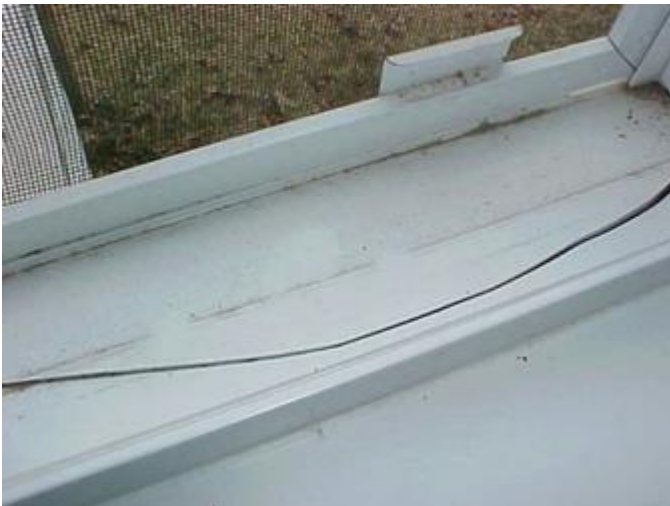
- ✕ **Issue** The window sill is damaged. This will allow water penetration.
- Location** Living room, front right
- Action** *Repair or replace the window.*

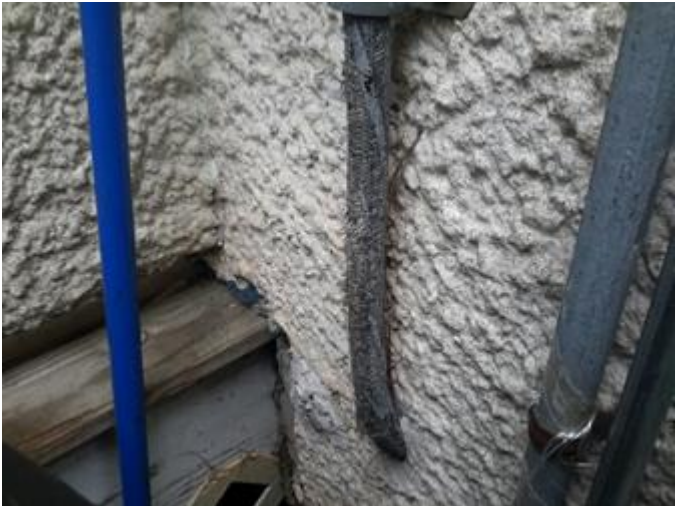
X Issue	There is deteriorated insulation on the service entrance cable. This is a safety hazard.
Location	Exterior left rear corner below the meter
Action	<i>Hire an electrician to make required repairs.</i>

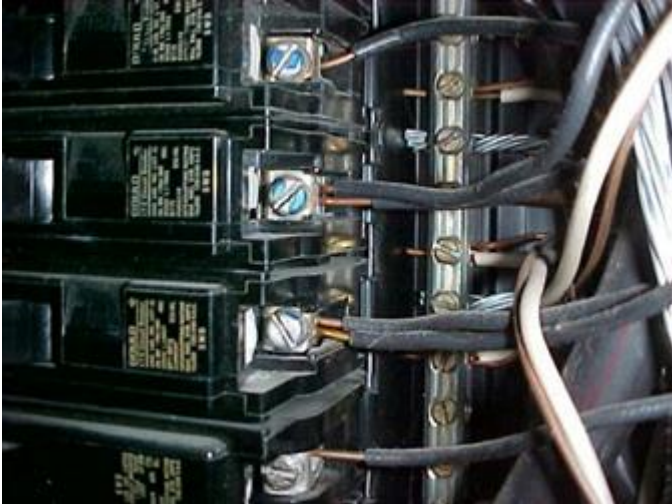
- ✕ **Issue** There are double-tapped breakers at the electrical panel. Most contacts are not designed to safely secure more than one wire.
- Location** Main panel
- Action** *Hire an electrician to make required repairs.*

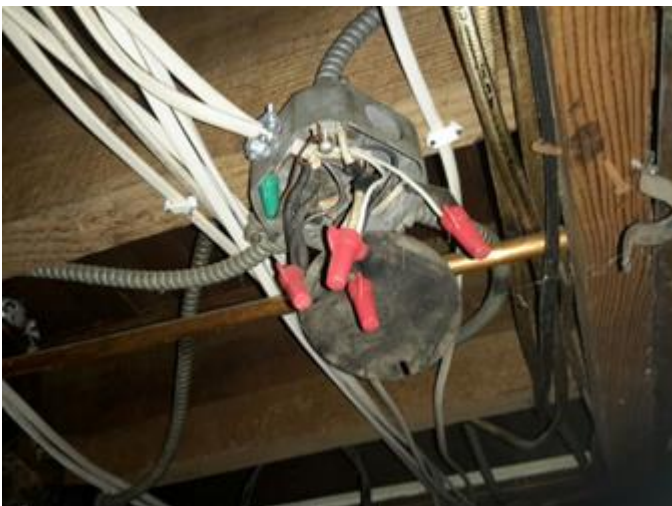
- ✕ **Issue** There are missing cover plates. This is a safety concern that defeats the enclosure's fire rating and permits contact with energized components.
- Location** Basement near the steps
- Action** *Hire an electrician to make required repairs.*

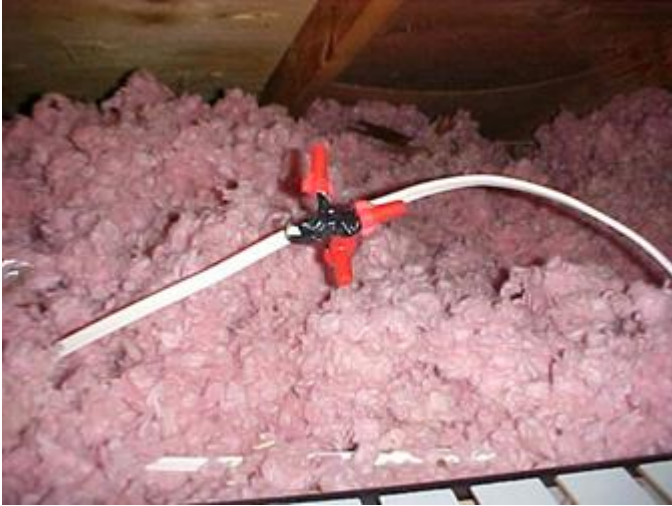
- ❌ **Issue** There are exposed wire splices. This is a safety hazard. All wiring splices must be in an approved junction box with a proper cover and permanently accessible.
- Location** Attic at the front right corner
- Action** Hire an electrician to make required repairs.

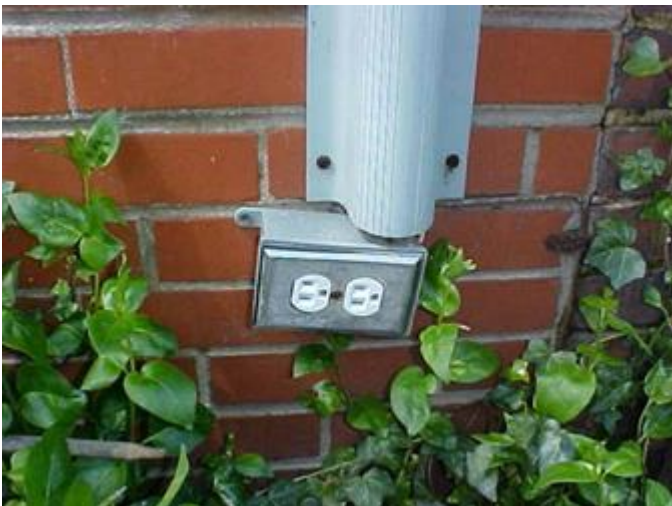
- ❌ **Issue** The receptacle is in a wet area without a weather cover. This is a safety hazard.
- Location** Right side exterior wall
- Action** Install a weather-rated exterior cover.

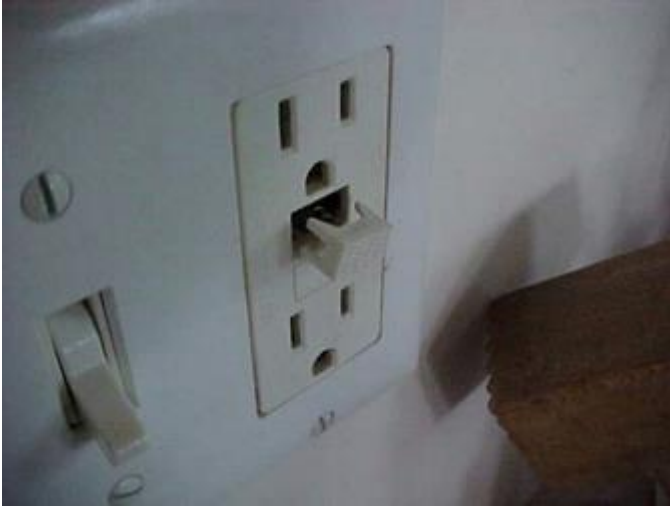
- ✗ Issue There is a defective GFCI receptacle. This is a safety hazard.
Location Kitchen counter near the sink
Action *Hire an electrician to make required repairs.*

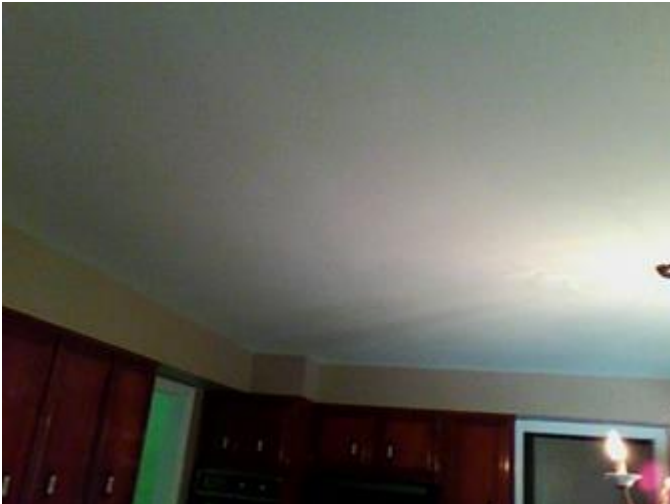
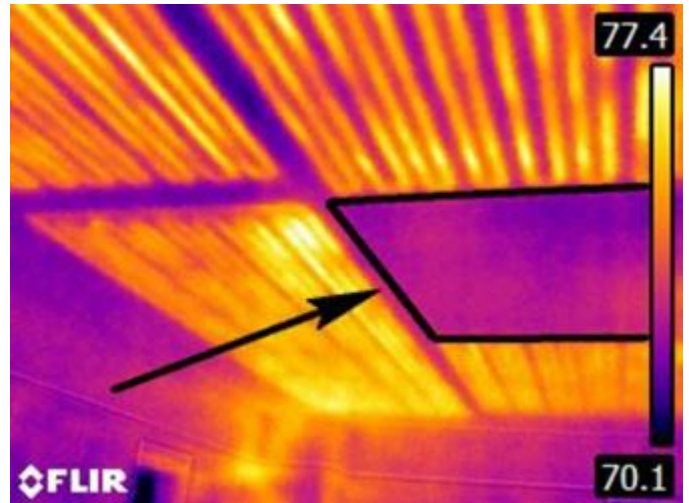
- 24 One of the panels in the radiant heating system is inoperative. It does not respond to the normal controls. It is outlined and indicated in the included infrared image. Location: Den ceiling, right side. *Hire an electrician to make required repairs.*

Location Den ceiling, right side

Action Hire an electrician to make required repairs.

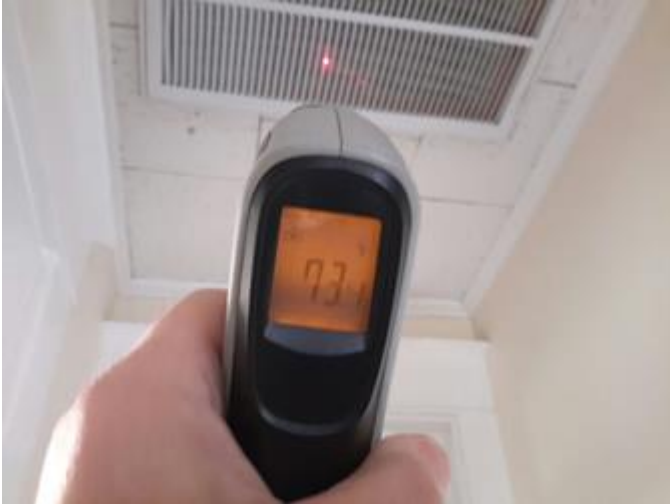
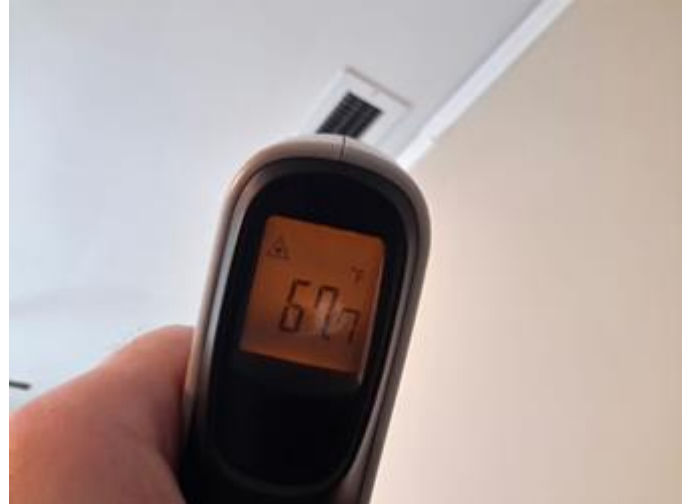
- ❌ **Issue** The temperature differential is too low. This "Delta-T" is the temperature difference between the supply and return air. The proper range is 14F - 22F.
- Location** Second floor system
- Action** Hire an HVAC contractor to make required repairs.

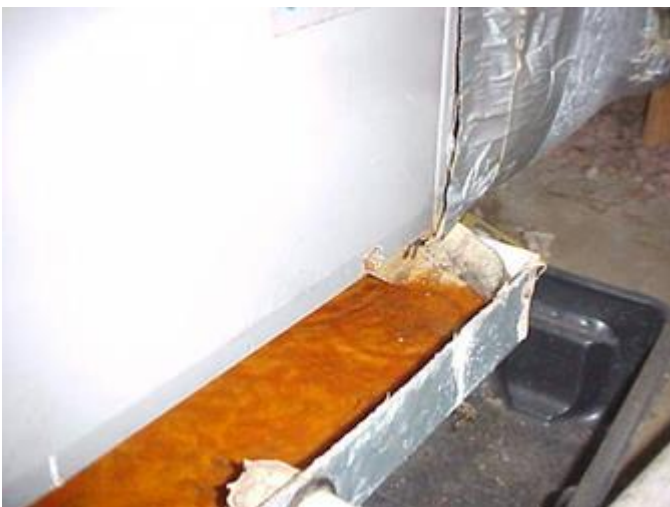
- ❌ **Issue** The primary condensate system is leaking into the secondary catch pan. The catch pan is not draining properly and is retaining water. This will encourage corrosion, possible mildew or mold growth, and may allow water damage.
- Location** Attic air handler
- Action** Hire an HVAC contractor to make required repairs.

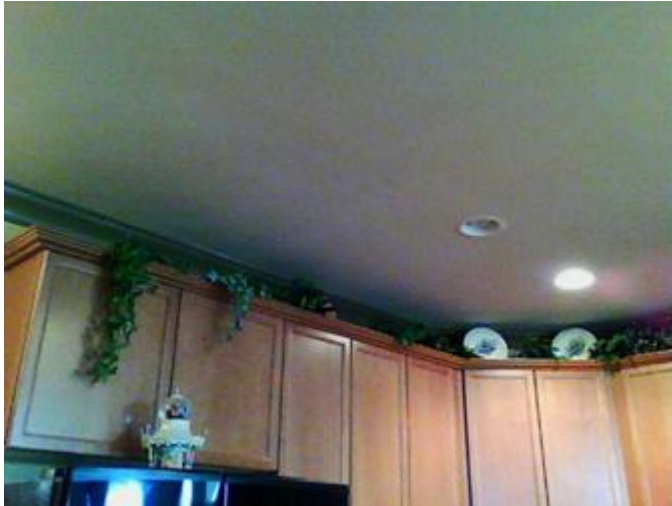
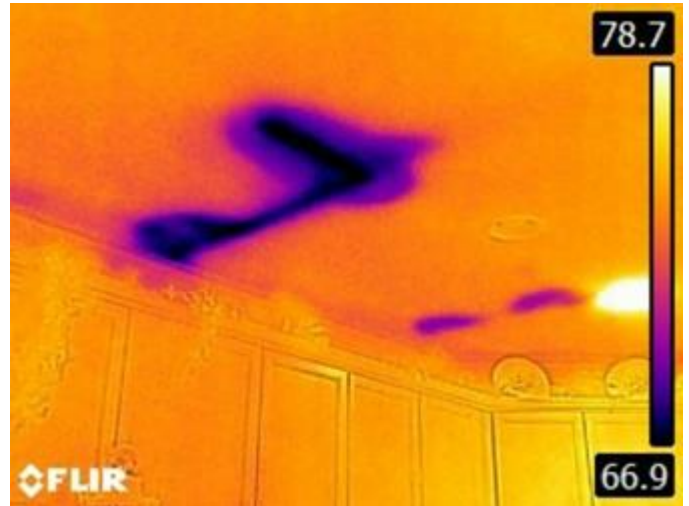
- X** Issue There is evidence that the drain pipes are leaking. The infrared image included shows a pattern consistent with moisture pooling below the tub and sink drains. Moisture is confirmed with a moisture meter. This will cause water damage to the surrounding areas.
- Location Kitchen ceiling below the master bathroom
- Action Hire a plumber to make required repairs.

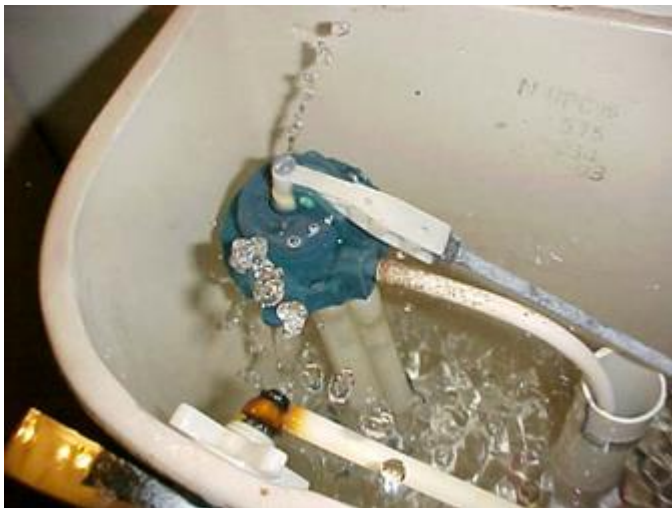
- X** Issue The toilet's fill valve is damaged. This affects proper function.
- Location Powder room
- Action Repair or replace the fill valve assembly.

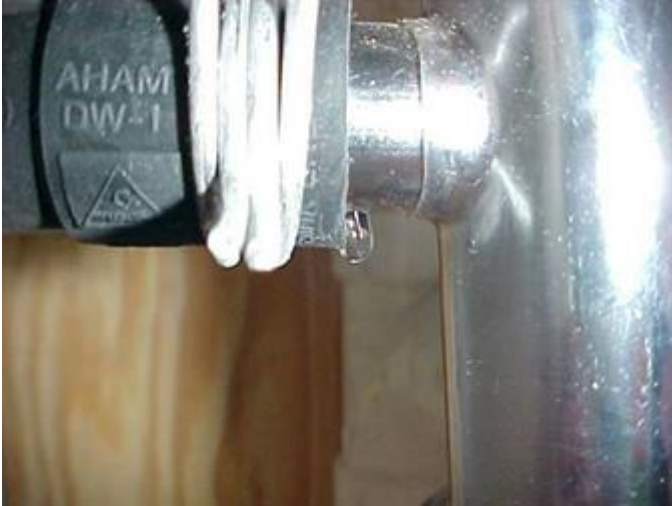
- ✕ Issue The sink drain is leaking. This can allow water damage.
- Location Upstairs hall bathroom
- Action Hire a plumber to make required repairs.

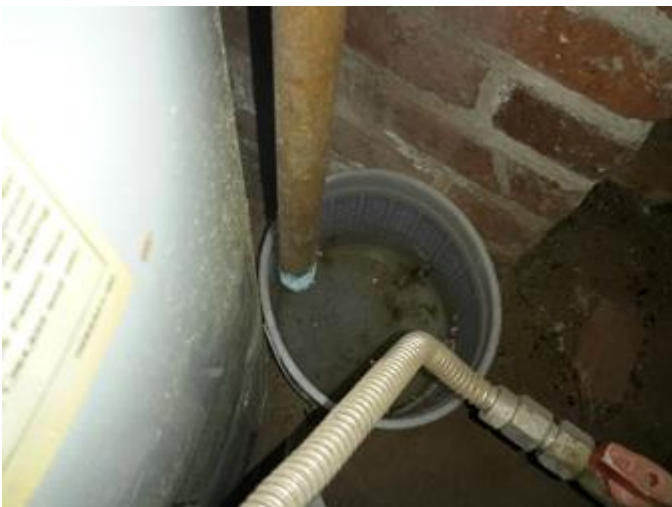
- ✕ Issue The water heater's Temperature Pressure Relief Valve (TPRV) is leaking. It may not function as required, and can cause water damage.
- Location Basement water heater
- Action Hire a plumber to make required repairs.

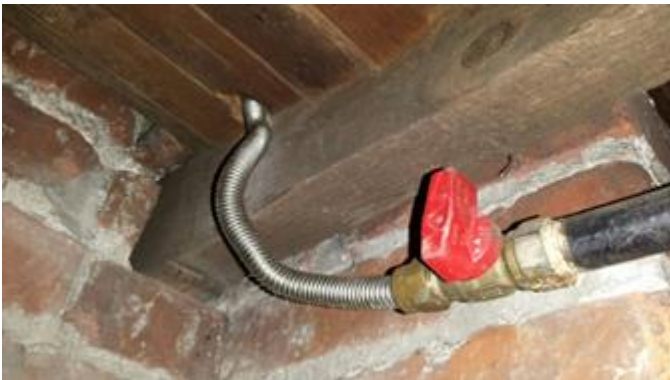
- ✗ Issue The flexible appliance connector is improperly installed. It is passing through the floor from the basement into the fireplace. This is a safety hazard.
- Location Basement below the fireplace
- Action Hire a contractor to make required repairs.
