HOME INSPECTION

08/28/18

5432 Test Ave

St. Louis, MO 63139

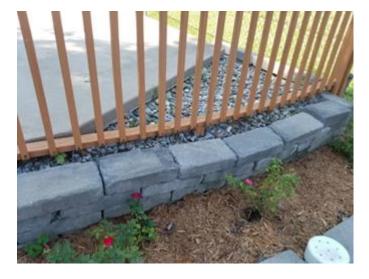
Location Rear

There is minor movement in the retaining wall. The cause for this should be determined, and repairs

made to prevent further movement.

Action Hire a contractor to evaluate the movement and provide repairs as needed.

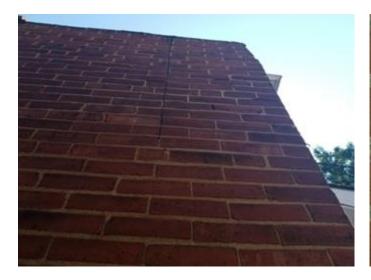
Location Right Side

Issue There are deteriorated mortar joints in the siding. This permits moisture penetration and will cause further damage.

Action Repair the mortar joints.

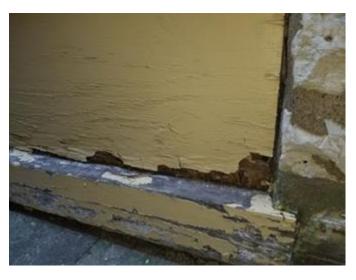
Location Left side basement windows.

Issue The paint on the trim is peeling or blistering. This implies that moisture has penetrated behind the finishes.

Repair or replace the trim and repair any damage which may be revealed. Action

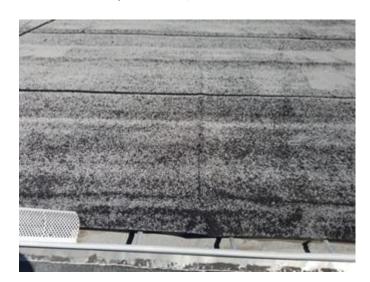
Issue The roof covering is old, worn, and deteriorated. Repairs would not be practical or reliable.

Location Main roof Action Replace the roof.

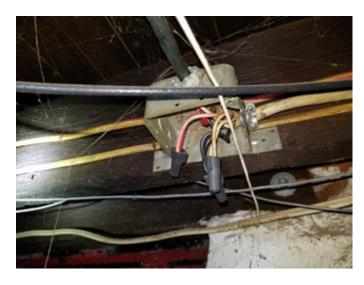
Location Basement

There are missing junction box covers. This is a safety concern that defeats the box's fire rating and permits contact with energized components.

Action Hire a contractor to make required repairs.

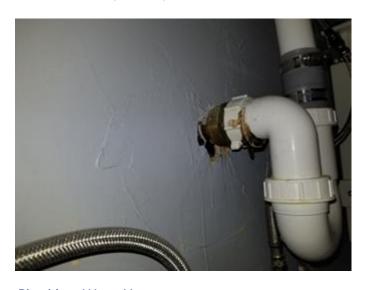
Location Bathroom

Issue The sink drain is leaking. This can allow water damage.

Action Repair or replace the drain.
