PROPERTY INSPECTION REPORT

09/25/18

123 Old Coyote Trail
Skyfaller, TX 75757

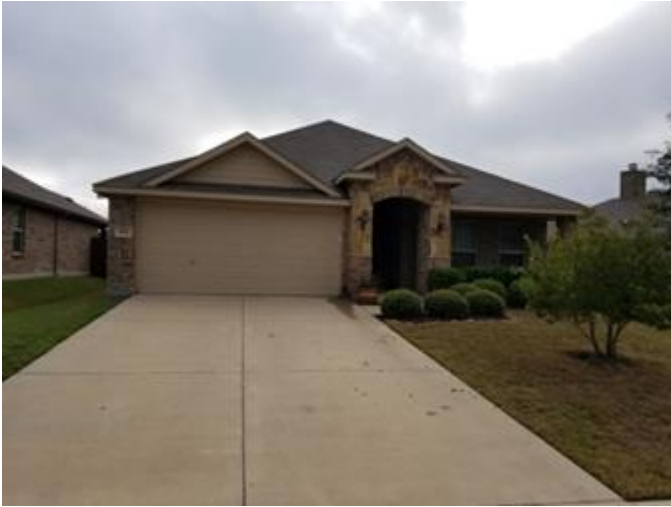
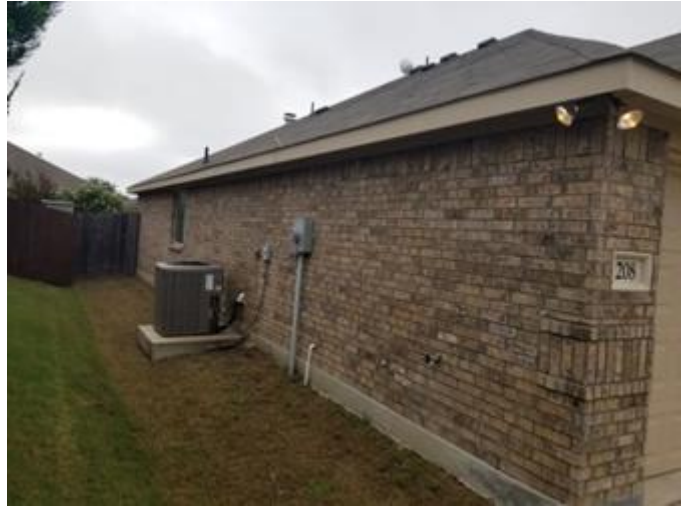
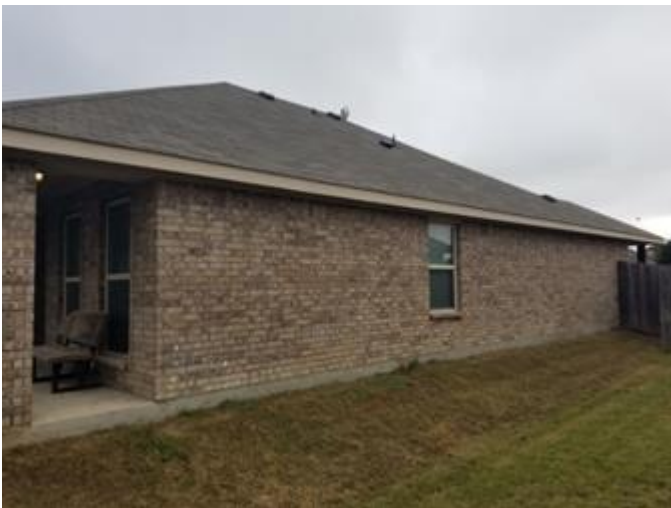
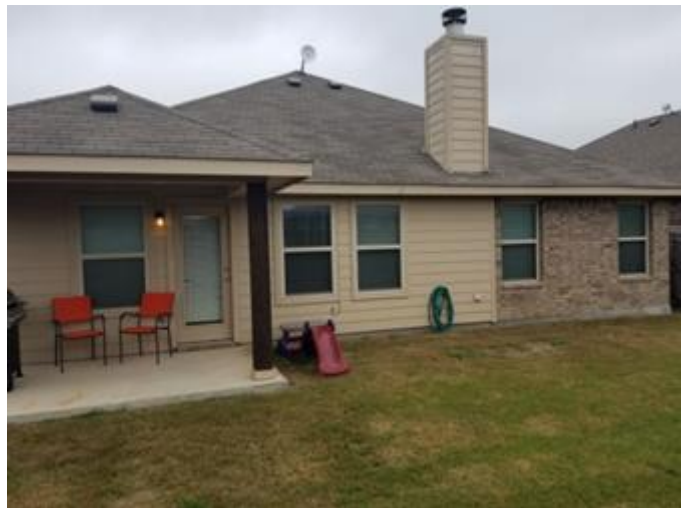
Photos of each side of the house
provide panoramic view and capture
condition of exterior at inspection date/time

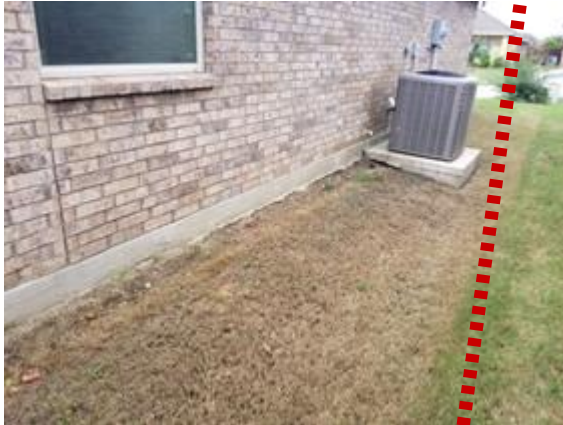
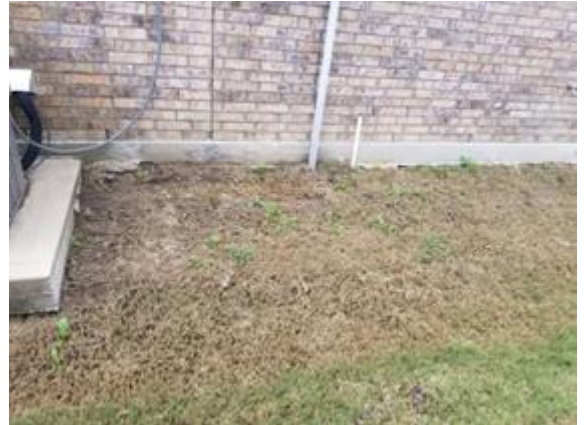
The grading is eroded next to the structure. This permits water to collect and penetrate the foundation. The cause of the erosion should be identified. Location: Right Side.

Regrade to divert surface water away from the foundation. The grade should be sloped at 1" per foot for up to 6' from the dwelling.

- 01 The grading is eroded next to the structure. This permits water to collect and penetrate the foundation. The cause of the erosion should be identified. Location: Right Side. *Regrade to divert surface water away from the foundation. The grade should be sloped at 1" per foot for up to 6' from the dwelling.*

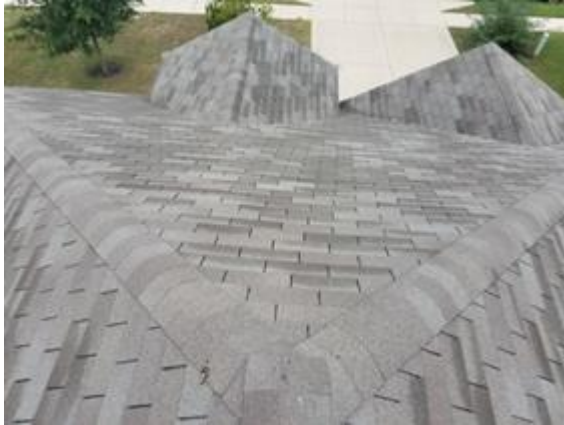
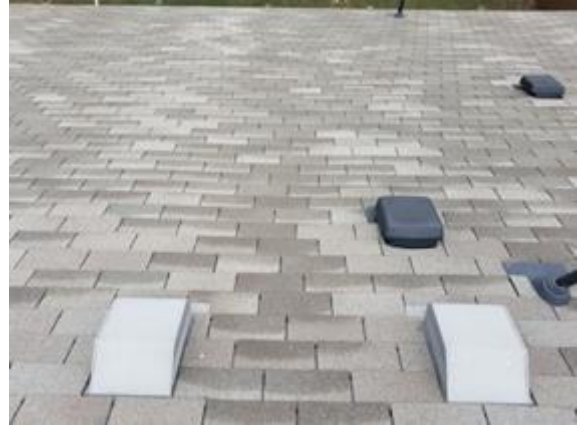
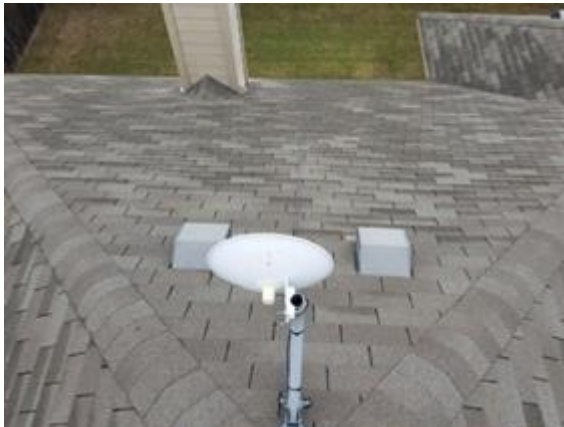
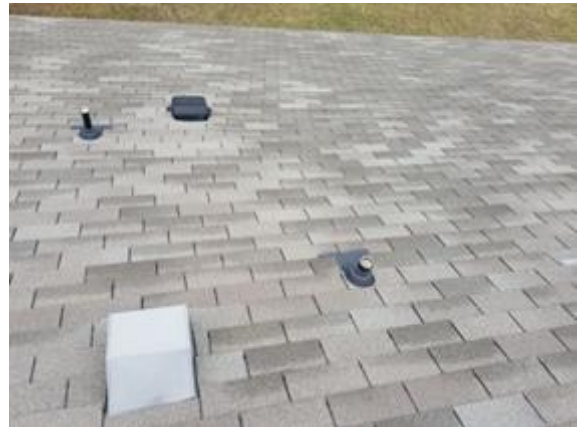
There are exposed nail heads. These are prone to rusting and permit water penetration. Location: Right and left.
Repair the roofing to eliminate the exposed nail heads.

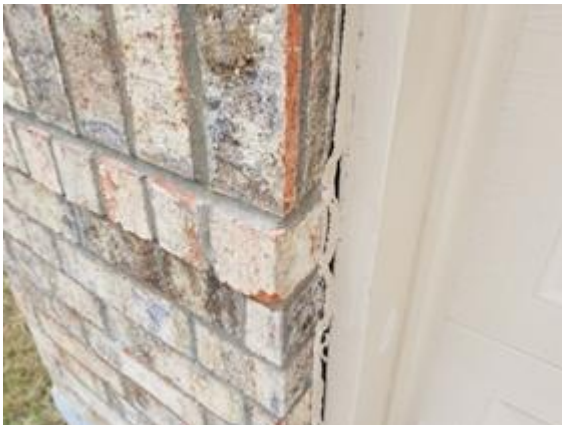
Caulking at garage trim boards. Location: Front.
Repair caulking

- 03 Caulking at garage trim boards. Location: Front. *Repair caulking*
04 No caulking around exterior light fixtures Location: Front. *Install caulking to properly seal light fixtures*
05 Rusting and steel lintels above windows and doors Location: Front. *Remove rust and paint to seal steel lintels*

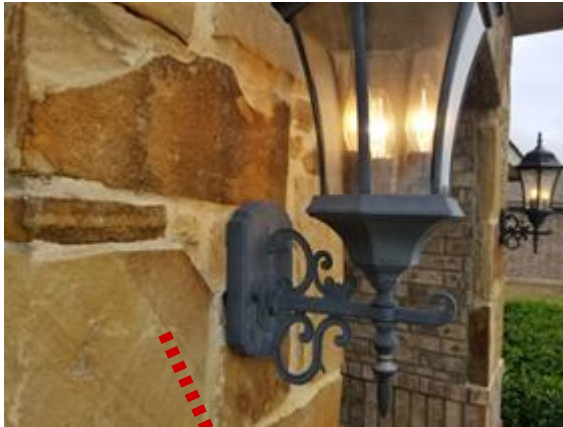
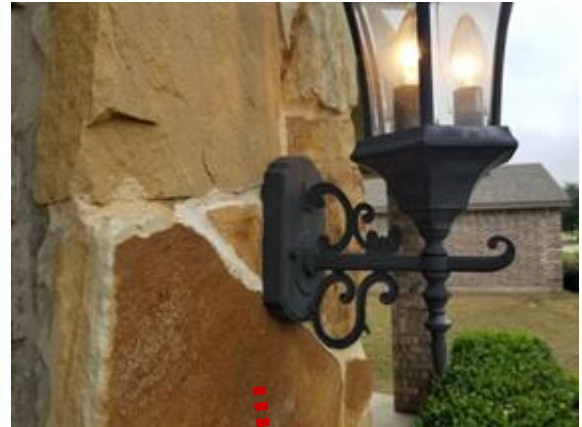
No caulking around exterior light fixtures Location: Front.
Install caulking to properly seal light fixtures

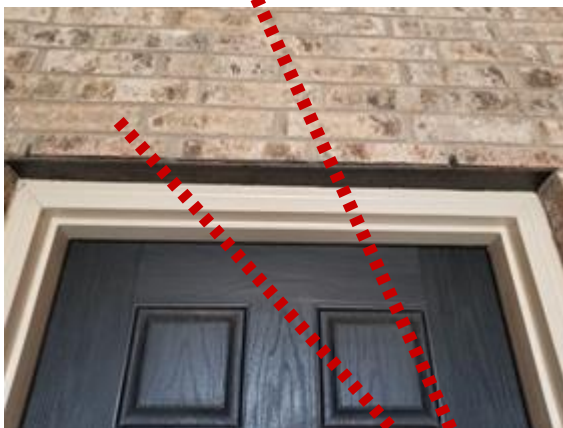
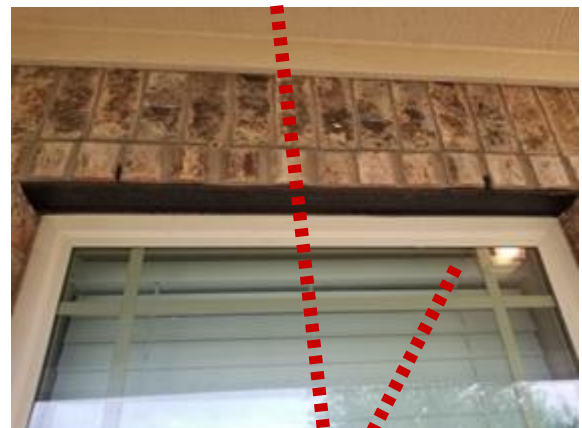
Rusting and steel lintels above windows and doors Location: Front.
Remove rust and paint to seal steel lintels

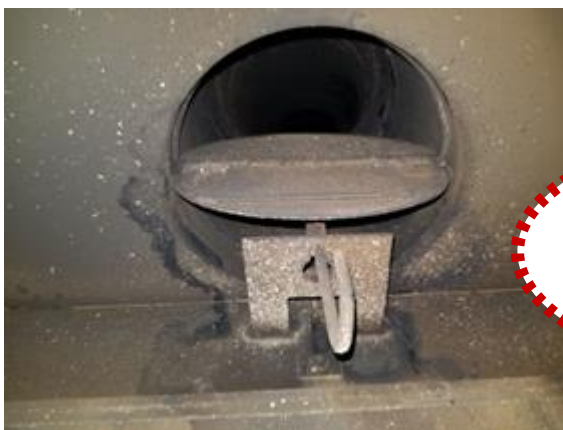
There is creosote accumulation in the fireplace and flue. This is a fire hazard. Location: Living Room.

Hire a contractor to clean the chimney and conduct a detailed inspection.

- 06 There is creosote accumulation in the fireplace and flue. This is a fire hazard. Location: Living Room. *Hire a contractor to clean the chimney and conduct a detailed inspection.*

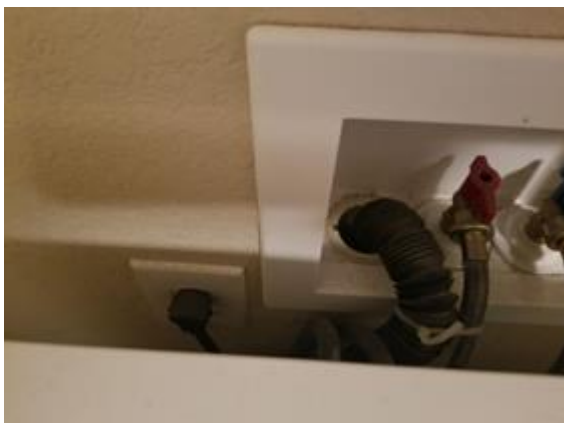
There is a standard receptacle installed in a location that currently mandates a GFCI device. While this may not have been required at installation, it is a safety hazard. Location: Laundry Room.
Hire an electrician to replace the receptacle.

- 07 There is a standard receptacle installed in a location that currently mandates a GFCI device. While this may not have been required at installation, it is a safety hazard. Location: Laundry Room. *Hire an electrician to replace the receptacle.*

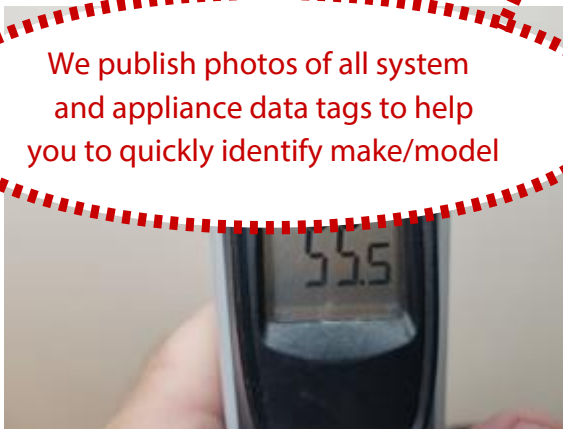
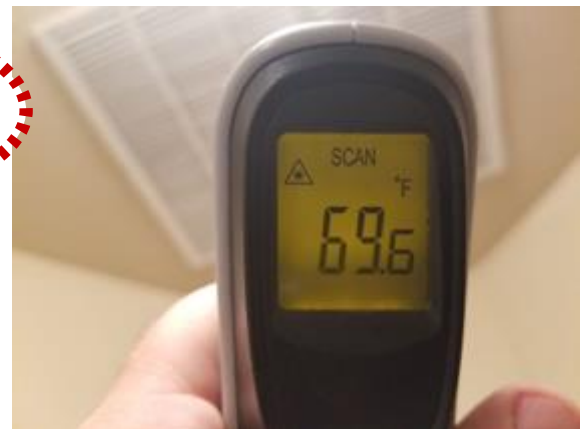
The compressor coils are dirty. This can affect efficiency. Location: First Floor.
Hire an HVAC contractor to clean the coils.

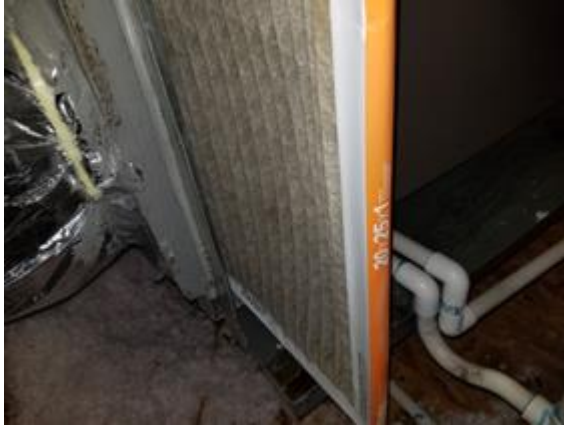
The air filter is dirty Location: First Floor.
Replace the air filter

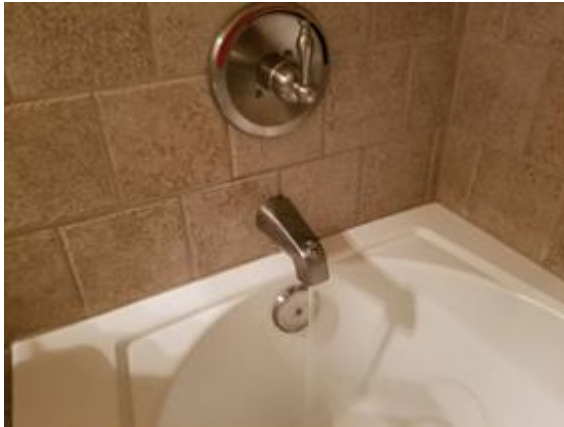
The tub/shower water pressure is too low. This affects proper function. Location: Hall bath.
Hire a plumber to evaluate the system and to make required repairs.

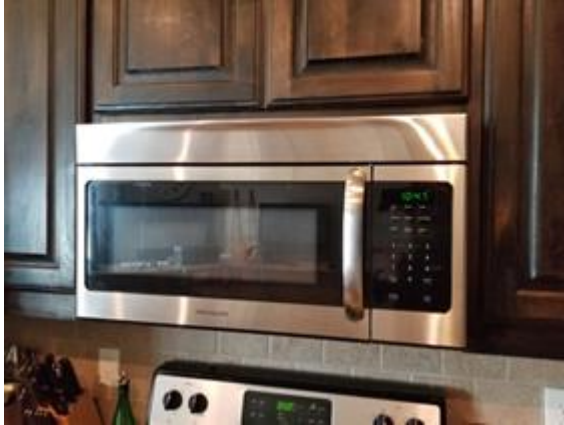
The exhaust fan is a recirculating type, i.e., the fan does not vent to the exterior. Clean the filter at regular intervals.

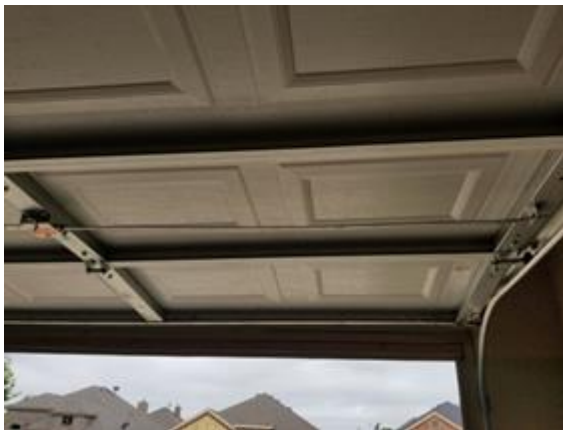
There is a manual lock bar installed Location: Garage.

Remove or disable manual lock bar

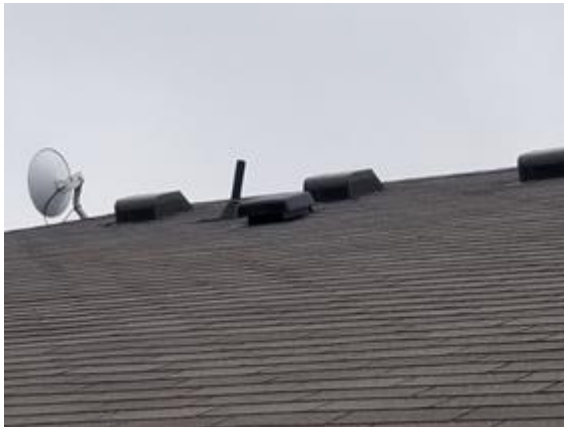
The dryer's vent exterior hood is screened. This is improper as it can cause lint build-up and create a fire hazard. Location: On the left side of the roof.
Replace with the proper type of vent for a dryer.

- 13 The dryer's vent exterior hood is screened. This is in
Location: On the left side of the roof. *Replace with*
14 The dryer's vent pipe has excessive lint buildup. This
