HOME INSPECTION

08/01/16

1234 Oak Street
Manassas, VA 20109

Prepared with care for
Joe Sample

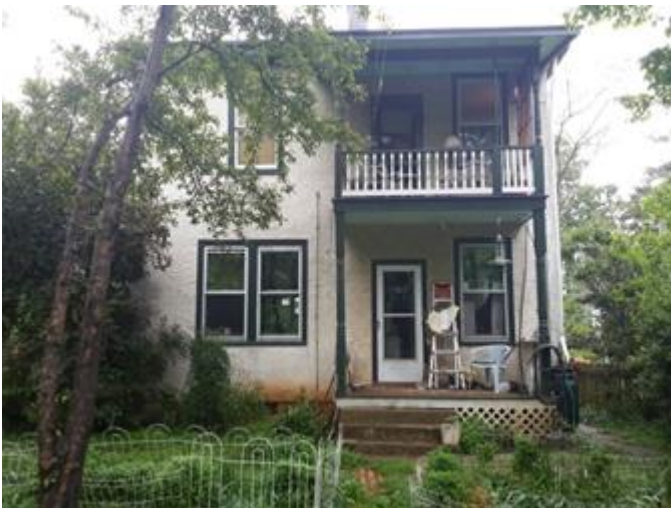
- 03 The handrail is missing. This is a safety hazard. Location: Front and rear porches. *Install a handrail.*
